August 25, 2016 2111 Del Monte Drive HPO File No. 160807 Landmark: TC Montgomery House

CERTIFICATE OF APPROPRIATENESS

Proposal: Alteration - Windows. A COA was approved in May 2016 for to shutter two windows and

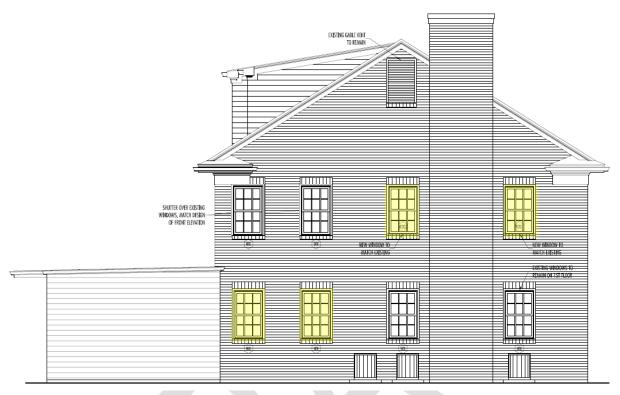
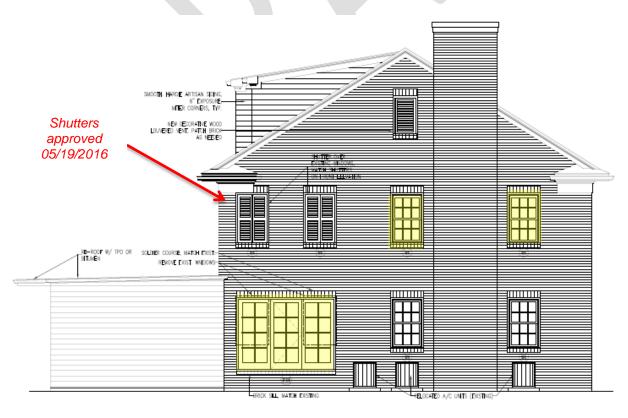
EAST SIDE ELEVATION

EXISTING - YELLOW WINDOWS ARE TO BE REPLACED

Side Elevation: The applicant proposes to remove two original windows and openings at the rear of the first floor

(East) and install two new windows and a French door, all require new openings. The applicant also proposes to replace two original windows towards the front of the elevation on the second story.

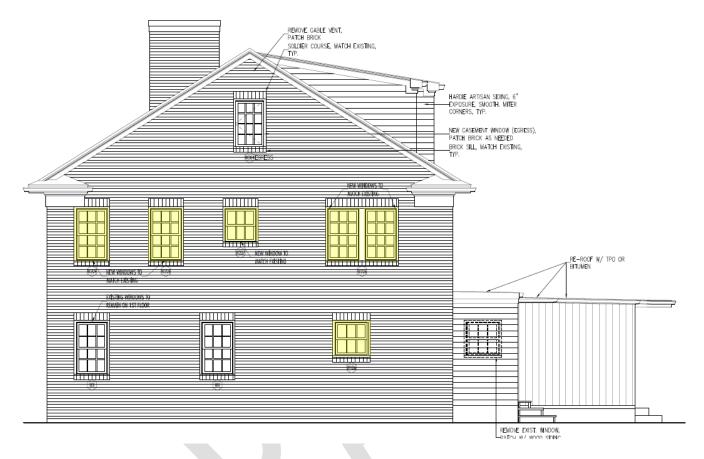
WEST SIDE ELEVATION

Side Elevation: The applicant also proposes to remove and replace a window towards the rear of the west

(West) elevation and remove and replace all six original windows on the second story west elevation. See

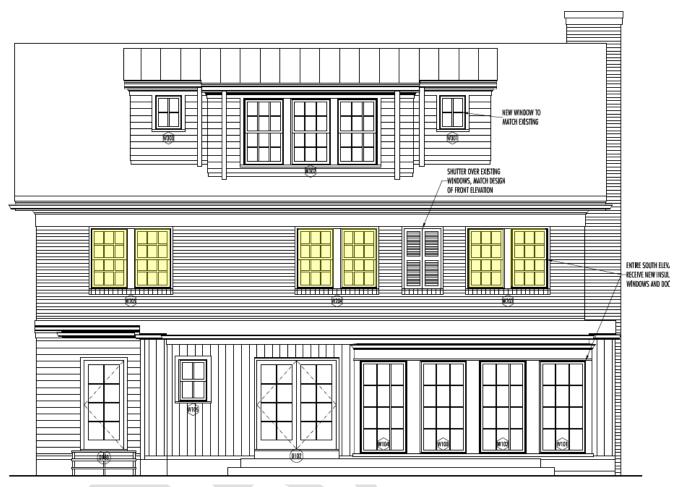
SOUTH (REAR) ELEVATION

Rear Elevation: The applicant proposes to remove and replace all original windows on the second floor. This work

(South) is not visible from the public right-of-way. See drawings for more detail.

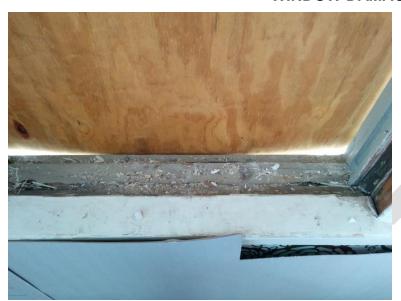
Window W206: Sill damaged due to rot

Recommendation: Approval with conditions: Restore and retain any operable window. Approval to replace

windows W201, W202, W203, W204, W205, W206, W207, W208, W209 with salvaged

windows from the rear of the structure.

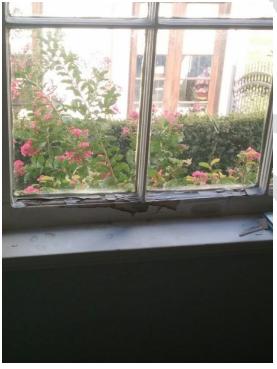
Window W208: Paint lifted from sash due to improper AC conditions

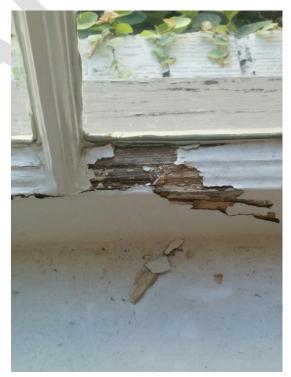
Window W209: Paint lifted from sash due to improper AC conditions
